REC'D 6-19-87  
FB.RCRA RECORDS CENTER  
FACILITY Ciba Geigy Corp  
ID. NO. RID001194323  
FILE LOC. R-5  
OTHER \_\_\_\_\_VISUAL SITE INSPECTION REPORT  
RCRA FACILITY ASSESSMENT  
CIBA-GEIGY CORPORATION  
CRANSTON, RHODE ISLAND

U.S. ENVIRONMENTAL PROTECTION AGENCY  
Office of Waste Programs Enforcement  
Washington, D.C. 20460

Work Assignment No.	:	265
EPA Region	:	I
Facility ID No.	:	RID001194323
Date Prepared	:	June 11, 1987
Contract No.	:	68-01-7331
CDM Federal Programs	:	
Corporation Document No.	:	T265-R01-RT-AQXF-3
Prepared By	:	Versar
Work Assignment Project Manager	:	Dennis Giestra
Telephone Number	:	(703) 750-3000
Primary Contact	:	Frank Battaglia
Telephone Number	:	(617) 223-1961

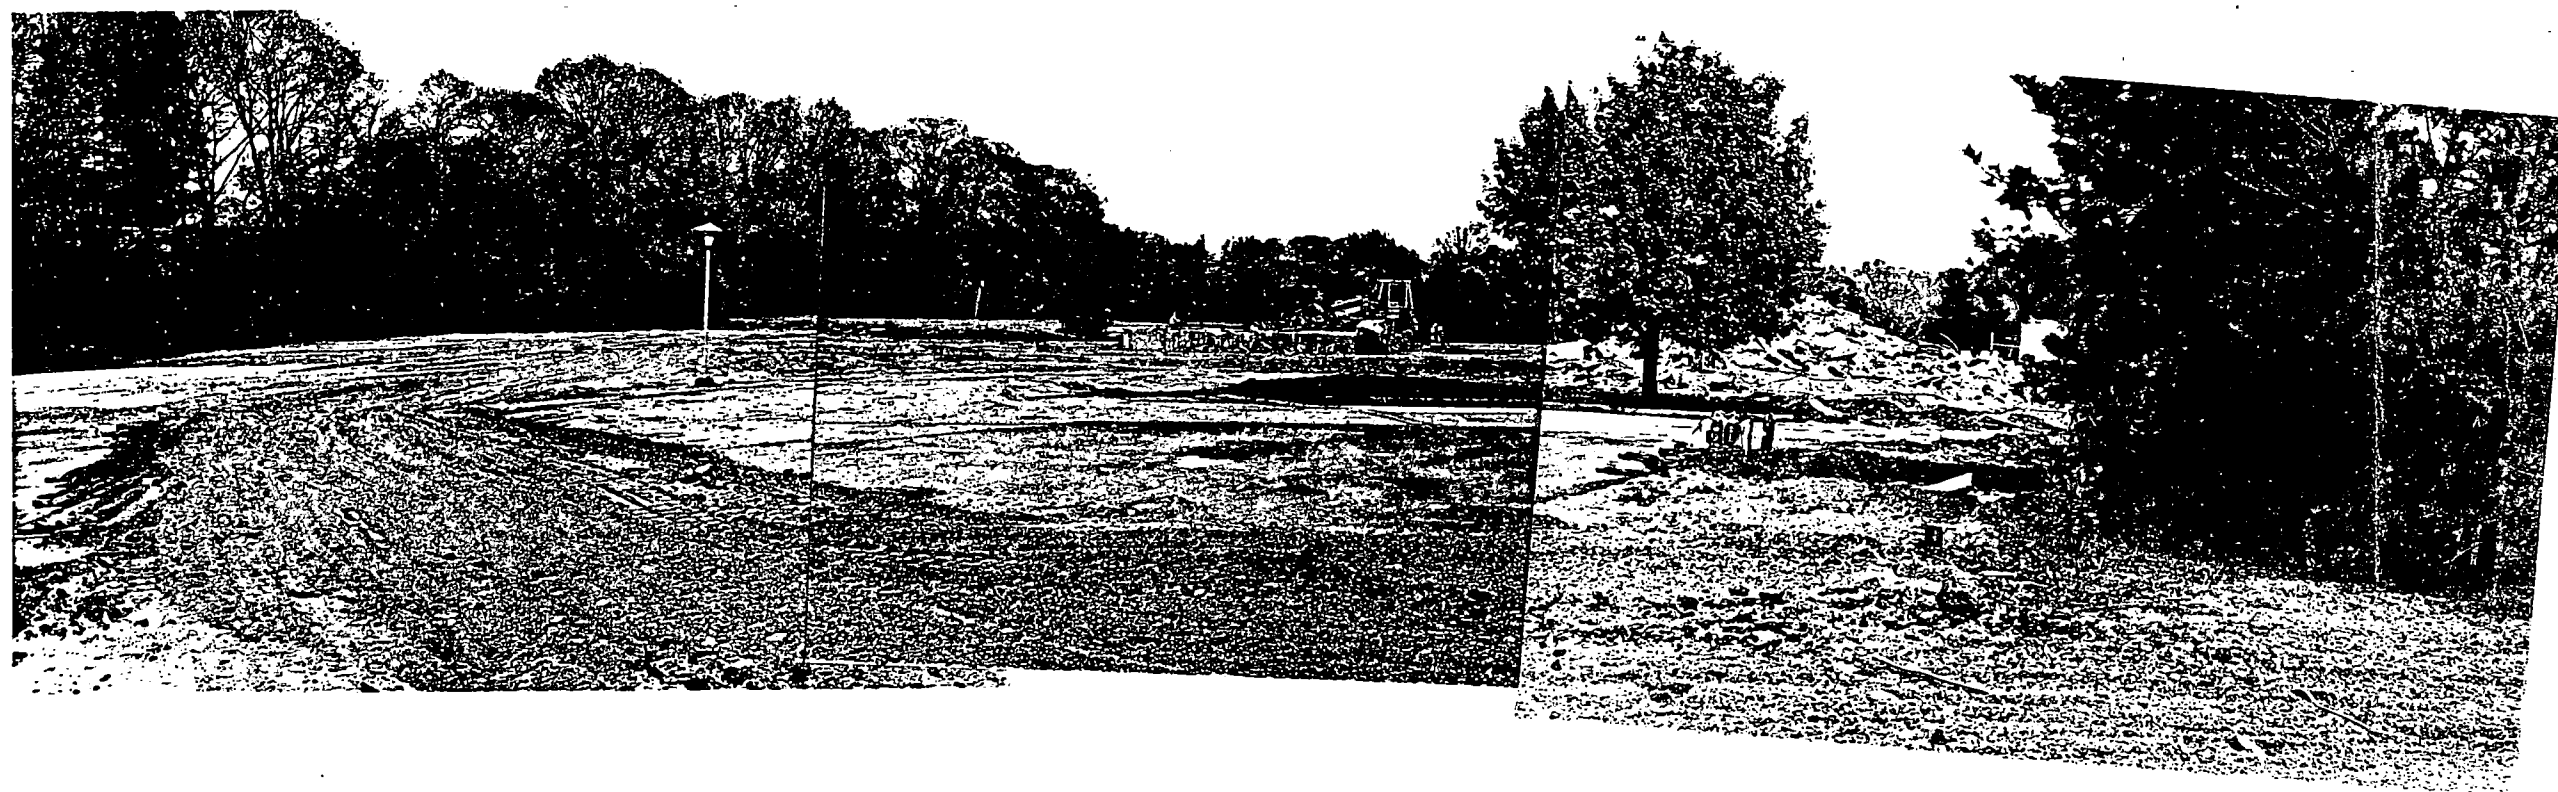
PHOTO 18

The general location of SWMU 10 was found at the former wastewater treatment plant site (Photos 17 and 18). The SWMU was identified as a result of a rupture in an underground line feeding two of the three equalization tanks (Ciba-Geigy, 1983). All structures and facilities at the treatment plant have been removed. Soils have been excavated, backfilled, and graded. The area surrounding the point of the pipeline rupture and the drainage pathway from the SWMU to the river revealed no evidence of past release.

SUBJECT: FORMER LOCATION OF WASTEWATER TREATMENT PLANT LOOKING NORTHEAST.  
LOCATION: CIBA-GEIGY, CRANSTON, RHODE ISLAND  
DATE: MAY 8, 1987

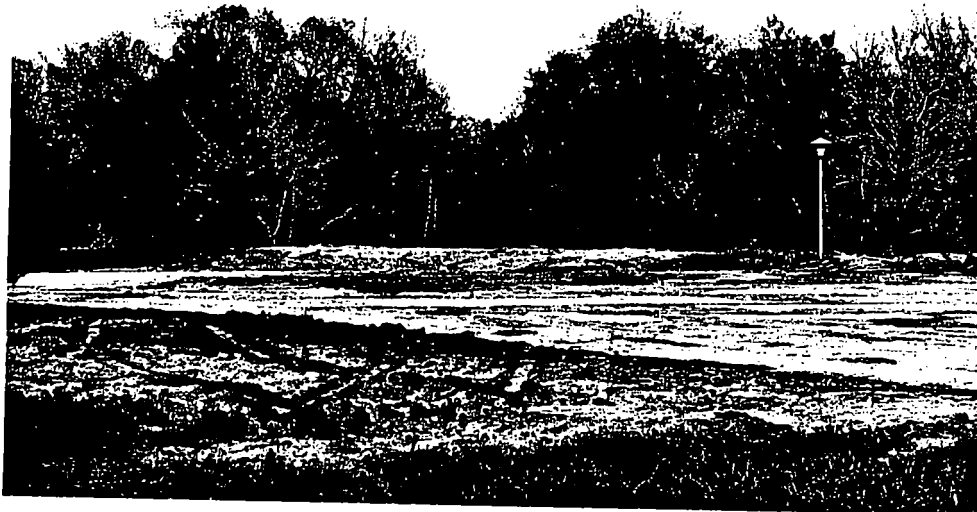
PHOTO 19

Cavitation of the soils around the ruptured pipeline allowed the discharge to flow to the ground surface where it was diverted to the facility's 001 outfall (Photo 19). Outfall 001 was a diffusion type outfall located on the bottom of the river used primarily for the discharge of pretreated effluent from the treatment plant. No information regarding any residual contamination in the area of the pipeline break exists. Contaminant migration is potentially via surface

SUBJECT: FORMER LOCATION OF CLARIFIER AT THE FACILITY'S WASTEWATER TREATMENT PLANT,  
LOOKING SOUTH TOWARD THE RIVER.  
LOCATION: CIBA-GEIGY, CRANSTON, RHODE ISLAND  
DATE: MAY 8, 1987

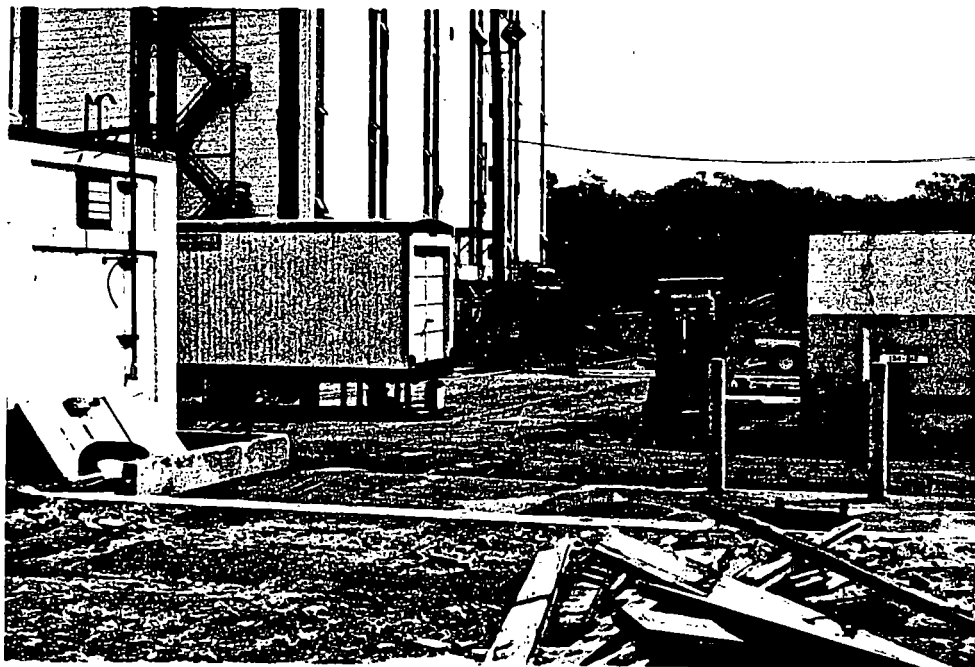
PHOTO 20

Building 11 was razed in October 1983. Analyses of groundwater samples in the vicinity of the building 11 sump at the time of demolition indicated a low-level presence of toluene (Ciba-Geigy, 1985a). The sump was located underground, had a capacity of 300 gallons, and was constructed of concrete. The sump operated as an overflow wier and contained a constant amount of water, which was normally pumped to the treatment plant. The area of the former building 11 is now paved (Photo 20).

Potential contaminant migration from the SWMU is through the subsurface to the ground water. Evidence of release may be documented by collecting groundwater samples adjacent to and downgradient of the SWMU within the former production area. The potential of exposure to contaminants from this SWMU would most likely be associated with use of the Pawtuxet River, since ground water in the area contributes to the flow of the river.

SUBJECT: LOCATION OF SWMU 11, BUILDING 11 AREA LOOKING SOUTH. THE BUILDING HAS BEEN  
RAZED AND THE AREA PAVED.

- SWMU 7 - Chlorosulfonic Acid Spill Area
- SWMU 8 - Potassium Ferrocyanide Spill Area
- SWMU 9 - Wastewater Pipeline Break (January 12, 1982)
- SWMU 10 - Wastewater Pipeline Break (September 7, 1983)
- SWMU 11 - Building 11 Area (Toluene)

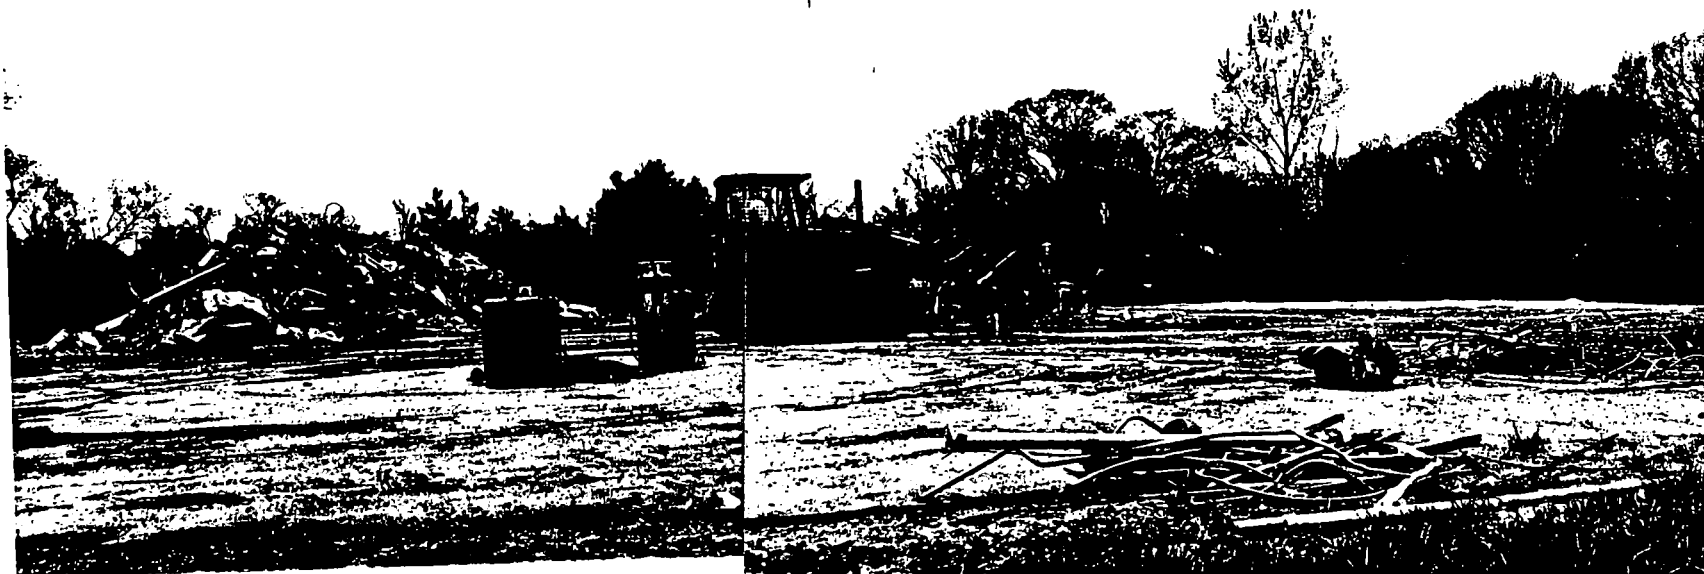
PHOTO 21

SUBJECT: FORMER LOCATION (FOREGROUND) OF TRICKLING FILTER AT THE FACILITY'S WASTEWATER  
TREATMENT PLANT LOOKING WEST.  
LOCATION: CIBA-GEIGY, CRANSTON, RHODE ISLAND  
DATE: MAY 8, 1987

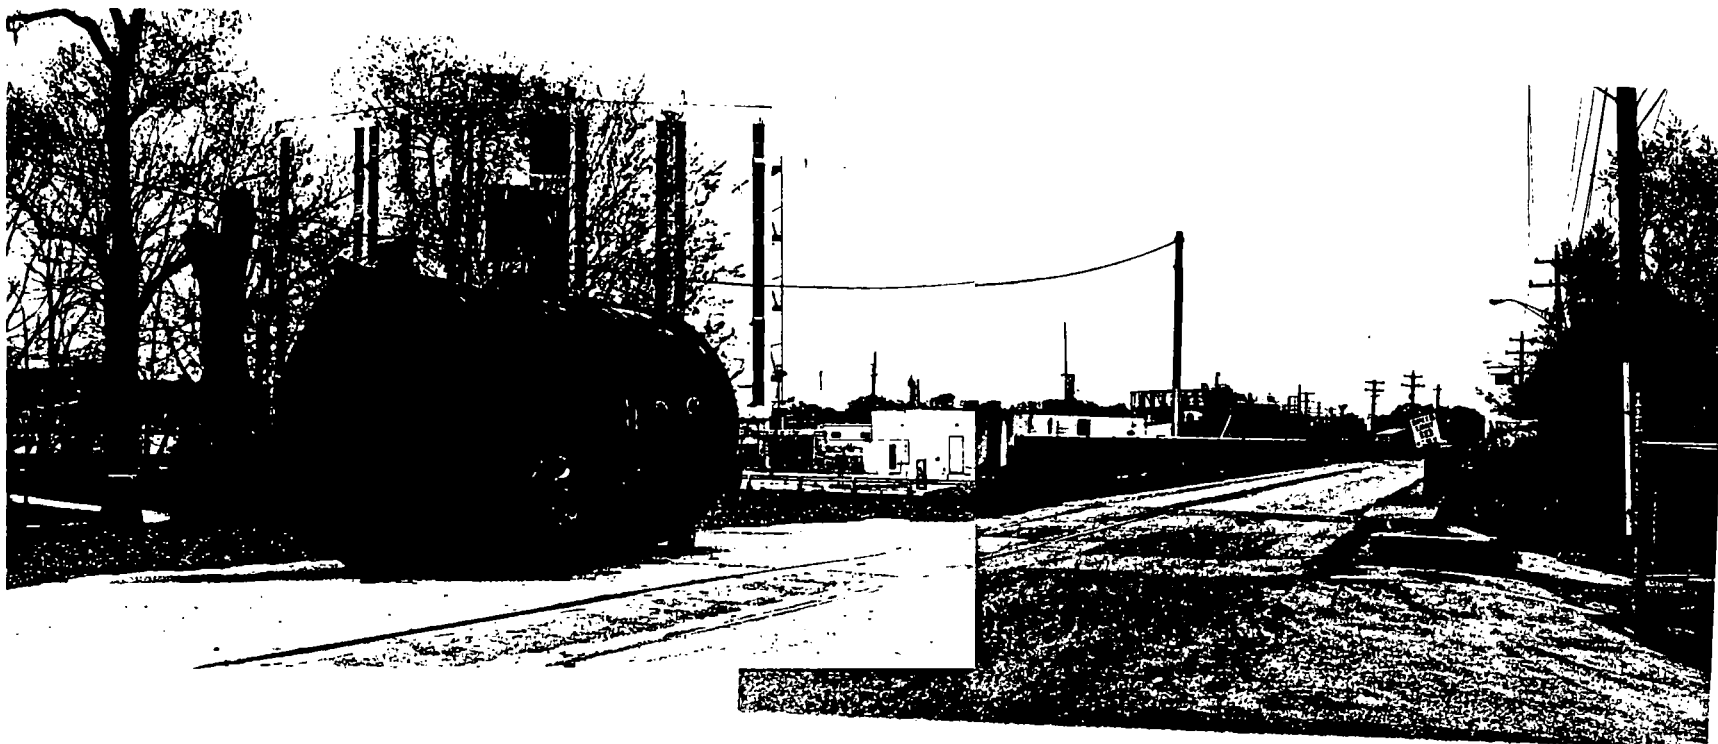
PHOTO 22

SUBJECT: VIEW OF CIBA-GEIGY FROM WARWICK SIDE OF PLANT LOOKING WEST. TANK IN FOREGROUND IS A FORMER UNDERGROUND STORAGE TANK.
